**Flood Control Project Maintenance
Levee Inspections**

Maintenance Issue Types Only, Levee Inspection Report By Mile - Spring 2016

Sutter Maintenance Yard Maintenance Area 0005

Waterway	Bank	Unit Miles	Inspection Start/End	Inspector
Unit No. 01 Butte Creek	Left	15.08	05/05/2016 05/05/2016	Keith Millard

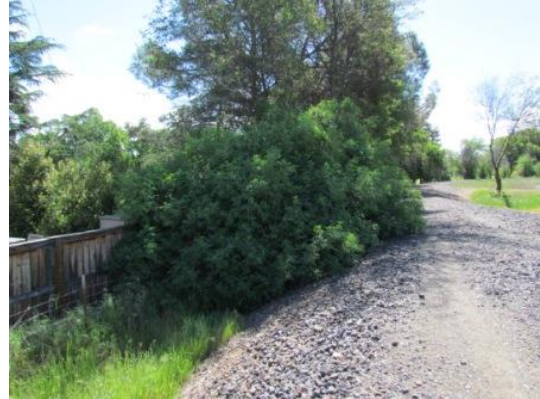
Photo 1 of 1 : SP_2016_MA0005_196_903_20160321_00020.jpg

LM Start	0.56	Rating **	M	Issue No.	903
LM End	0.56	Issue Type +	Ma	Location *	LS
Category	Earthen Levee			GPS Latitude/Longitude	
				Start	End
Item	Vegetation			39.690745 °	39.690745 °
				-121.777342 °	-121.777342 °
DWR ID	DWR_MA0005_01_s _ 2012_903				
Comment Code					
V4 : Elderberries are blocking visibility and flood fight capability.					
Inspector Comment

View of the large elderberries along the L/S toe.

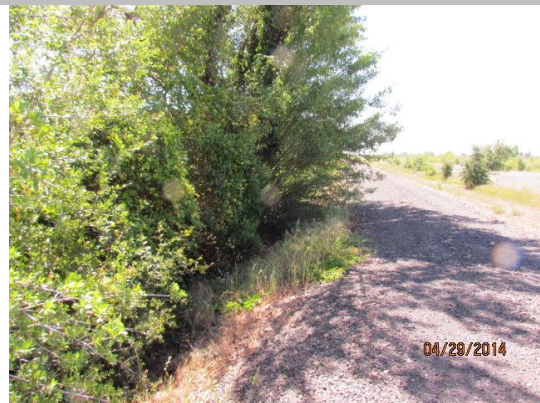
Photo 1 of 1 : SP_2016_MA0005_196_32_20160321_00012.jpg

LM Start	0.77	Rating **	M	Issue No.	32
LM End	0.77	Issue Type +	Ma	Location *	LS
Category	Earthen Levee			GPS Latitude/Longitude	
				Start	End
Item	Trim / Thin Trees			39.687917 °	39.687917 °
				-121.777393 °	-121.777393 °
DWR ID	DWR_MA0005_01_s _ 2014_32				
Comment Code					
T2 : Thin trees to allow visibility of the ground and room to flood fight.					
Inspector Comment

Trim the trees along the landside slope.

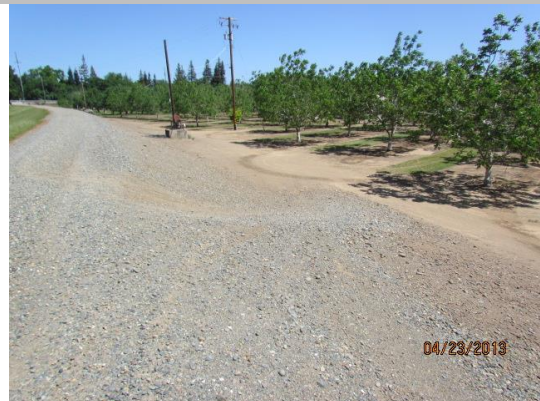
Photo 1 of 1 : SP_2016_MA0005_196_16_20160321_00007.jpg

View of the unauthorized vehicle ramp on the landside slope.

LM Start	1.61	Rating **	M	Issue No.	16
LM End	1.61	Issue Type +	Ma	Location *	LS
Category	Earthen Levee			GPS Latitude/Longitude	
				Start	End
Item	Slope Stability			39.676129 °	39.676129 °
				-121.778171 °	-121.778171 °
DWR ID	DWR_MA0005_01_s _ 2013_16				
Comment Code					
S3 : Repair the levee slope damaged by vehicle traffic and prevent access where possible.					
Inspector Comment

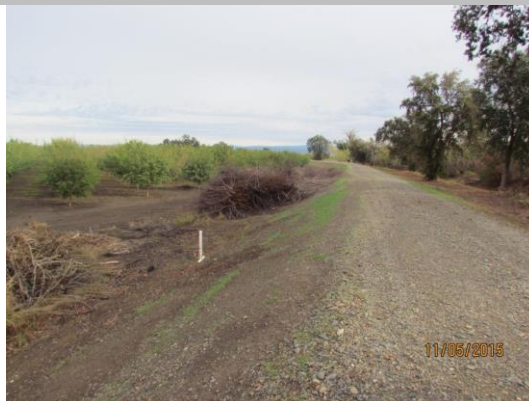
Photo 1 of 1 : SP_2016_MA0005_197_35_20160321_00014.jpg

View of the prunings along the landside slope.

LM Start	7.75	Rating **	M	Issue No.	35
LM End	7.75	Issue Type +	Ma	Location *	LS
Category	Earthen Levee			GPS Latitude/Longitude	
				Start	End
Item	Encroachments			39.605205 °	39.605205 °
				-121.788453 °	-121.788453 °
DWR ID	DWR_MA0005_02_s_2015_35				
Comment Code					
PR : Prunings					
Inspector Comment					
Remove the prunings from the landside slope.

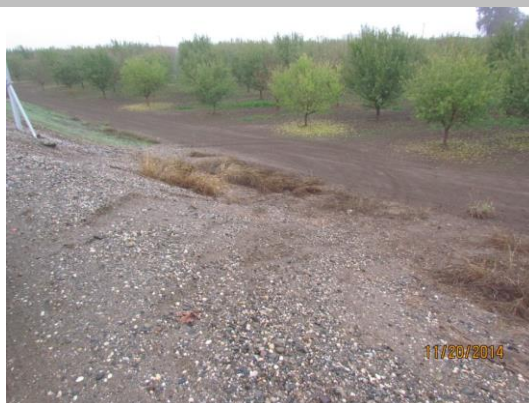
Photo 1 of 2 : SP_2016_MA0005_197_13_20160321_00005.jpg

View of the vehicle erosion along the landside slope.

LM Start	7.98	Rating **	M	Issue No.	13
LM End	7.98	Issue Type +	Ma	Location *	LS
Category	Earthen Levee			GPS Latitude/Longitude	
				Start	End
Item	Slope Stability			39.607710 °	39.607710 °
				-121.785868 °	-121.785868 °
DWR ID	DWR_MA0005_02_s_2012_13				
Comment Code					
S3 : Repair the levee slope damaged by vehicle traffic and prevent access where possible.					
Inspector Comment

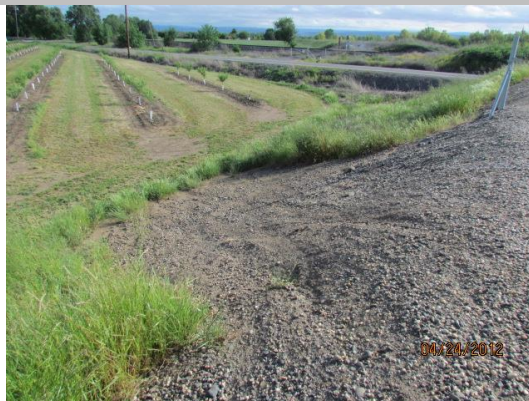
Photo 2 of 2 : SP_2016_MA0005_197_13_20160321_00006.jpg

View of the vehicle erosion along the slope.

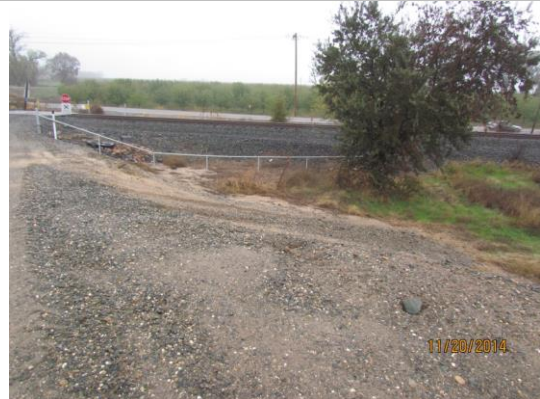
Photo 1 of 1 : SP_2016_MA0005_197_40_20160321_00016.jpg

View of the vehicle slope instability along the landside slope.

LM Start	8.06	Rating **	M	Issue No.	40
LM End	8.06	Issue Type +	Ma	Location *	LS
Category	Earthen Levee			GPS Latitude/Longitude	
				Start	End
Item	Slope Stability			39.608563 °	39.608563 °
				-121.785058 °	-121.785058 °
DWR ID	DWR_MA0005_02_f_2014_40				
Comment Code					
S3 : Repair the levee slope damaged by vehicle traffic and prevent access where possible.					
Inspector Comment

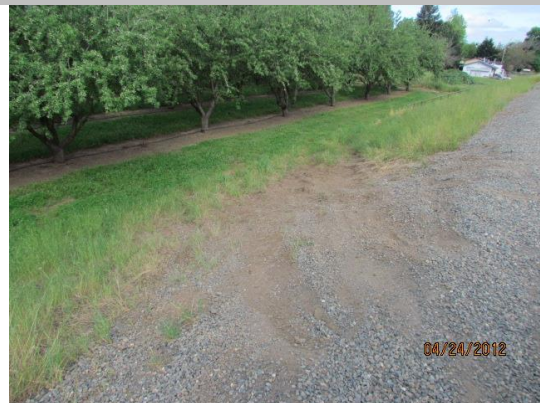
Photo 1 of 1 : SP_2016_MA0005_197_18_20160321_00008.jpg

View of the vehicle erosion along the slope of the levee.

LM Start	10.63	Rating **	M	Issue No.	18
LM End	10.63	Issue Type +	Ma	Location *	LS
Category	Earthen Levee			GPS Latitude/Longitude	
				Start	End
Item	Slope Stability			39.642061 °	39.642061 °
				-121.783861 °	-121.783861 °
DWR ID	DWR_MA0005_02_s_2012_18				
Comment Code					
S3 : Repair the levee slope damaged by vehicle traffic and prevent access where possible.					
Inspector Comment

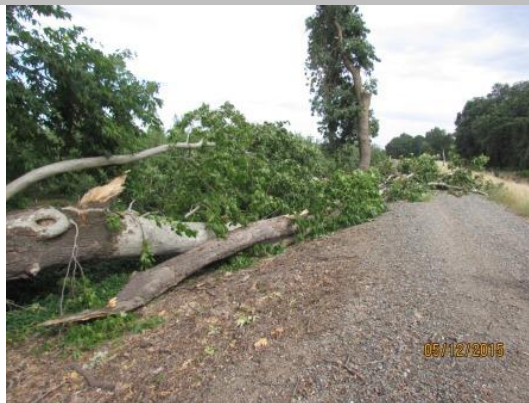
Photo 1 of 1 : SP_2016_MA0005_197_36_20160321_00015.jpg

LM Start	11.10	Rating **	U	Issue No.	36
LM End	11.10	Issue Type +	Ma	Location *	LS
Category	Earthen Levee			GPS Latitude/Longitude	
				Start	End
Item	Encroachments			39.647913 °	39.647913 °
				-121.788330 °	-121.788330 °
DWR ID	DWR_MA0005_02_s_2015_36				
Comment Code					
TR : Tree or limb					
Inspector Comment					
Fallen tree has been trimmed back since Spring 2015 inspection, but large pieces still remain which should be removed.

Remove the tree from the landside slope.

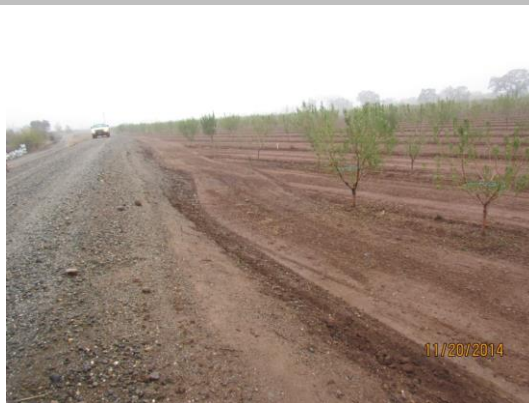
Photo 1 of 1 : SP_2016_MA0005_197_43_20160321_00018.jpg

View of the tilling into the landside slope.

LM Start	14.13	Rating **	U	Issue No.	43
LM End	14.13	Issue Type +	Ma	Location *	LS
Category	Earthen Levee			GPS Latitude/Longitude	
				Start	End
Item	Slope Stability			39.688715 °	39.688715 °
				-121.778345 °	-121.778345 °
DWR ID	DWR_MA0005_02_f_2014_43				
Comment Code					
S1 : Repair slope instability.					
Inspector Comment

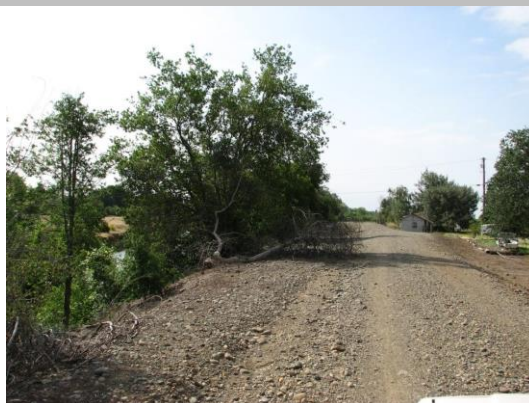
Photo 1 of 1 : SP_2016_MA0005_197_38_20160509_00063.jpg

LM Start	14.39	Rating **	M	Issue No.	38
LM End	14.39	Issue Type +	Ma	Location *	WS
Category	Earthen Levee			GPS Latitude/Longitude	
				Start	End
Item	Encroachments			39.692284 °	39.692284 °
				-121.779394 °	-121.779394 °
DWR ID	DWR_MA0005_02_s_2016_38				
Comment Code					
TR : Tree or limb					
Inspector Comment					
Fallen trees on W/S slope of levee.

5/5/2016: Remove fallen tree from W/S slope.

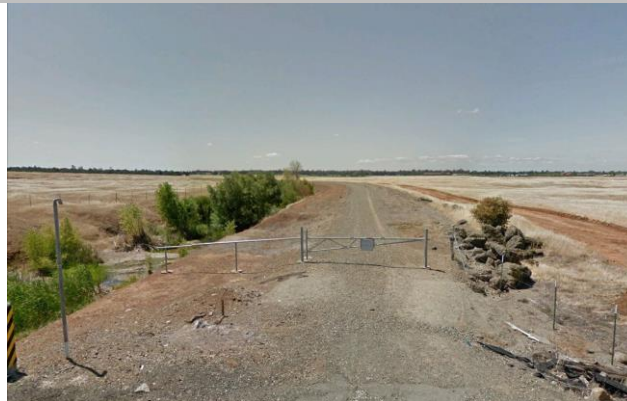
Photo 1 of 1 : SP_2016_MA0005_198_2_20160517_00001.jpg

LM Start	0.96	Rating **	A	Issue No.	2
LM End	0.96	Issue Type +	Ma	Location *	LS
Category	Earthen Levee			GPS Latitude/Longitude	
				Start	End
Item	Vegetation			39.726227 °	39.726227 °
				-121.781472 °	-121.781472 °
DWR ID	DWR_MA0005_03_s_2016_2				
Comment Code					
V1 : Control annual grass and weeds on the levee slopes and easements.					
Inspector Comment					
Yard doing a good job maintaining the Vegetation on the levee.

2016/05/05: Minimal vegetation on levee.
